REVITALIZATION MASTER PLAN

Bryant Square

HOWARD COUNTY
DEPARTMENT OF
PLANNING AND ZONING

MAY 15, 2003

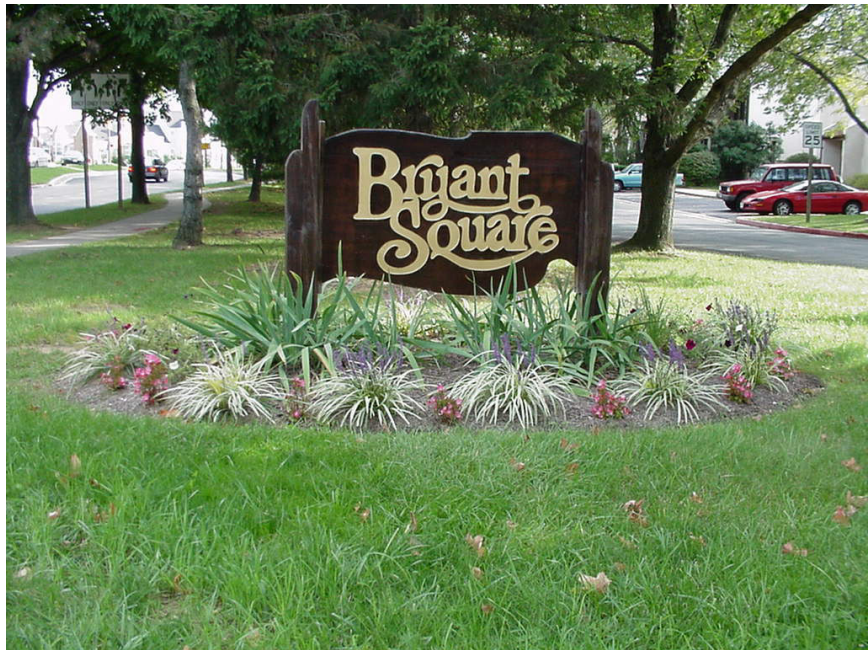
Figure 3: Entry Sign

The Main Entrance Area (See **Figure 2**) of Bryant Square is marked by an entry sign, which is visible from both directions along Twin Rivers Road (See **Figure 3**). There are two existing flower beds on each side of the entrance drive. The flower bed on the south side, directly under the Bryant Square sign is planted with Iris and Liriope. There is space within the flower bed for planting of spring and summer annuals. The flower bed on the north side is a small oval-shape bed, which is currently planted with Cone Flower and has space for spring and summer annuals. Directly to the north east of this flower bed is a utility box positioned within a shrub bed. It is currently planted with deciduous shrubs, which had been disturbed by recent utility work.

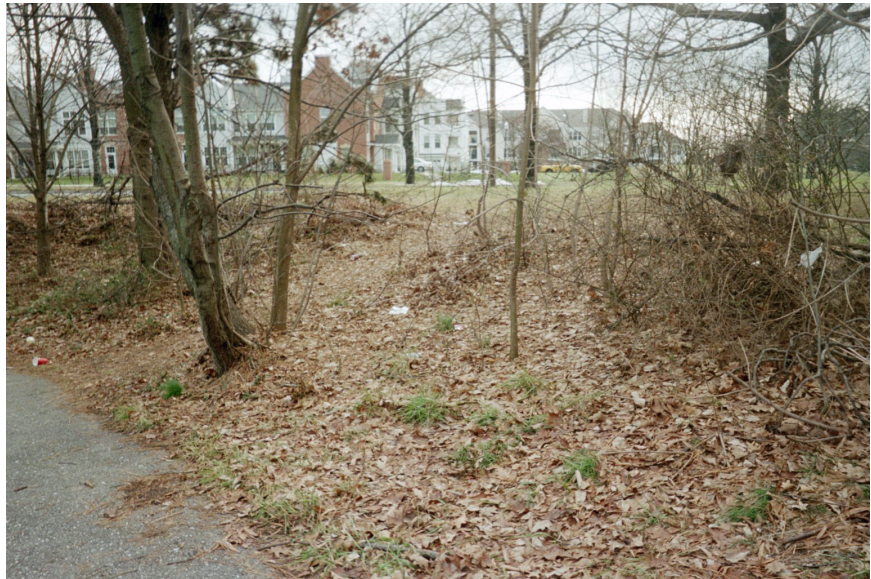
The Southern Boundary Area is primarily a large open space, which gently slopes from southwest to northeast (See **Figure 4**). The trail wraps around this open space and terminates at the pedestrian tunnel under Governor Warfield Parkway. The slope between the trail and the property boundary is in fair condition, but has worn pedestrian paths used as a cut-through to the adjacent property (See **Figure 5**).

Figure 5: Slope Between Trail and Property Boundary Showing Worn Pedestrian Paths

Underplant vegetated slopes between trail and property boundary to direct pedestrian traffic along trail with shrubs and small flowering trees. Consider installing a paved path connecting Bryant Square to the Century Plaza property for trail access.

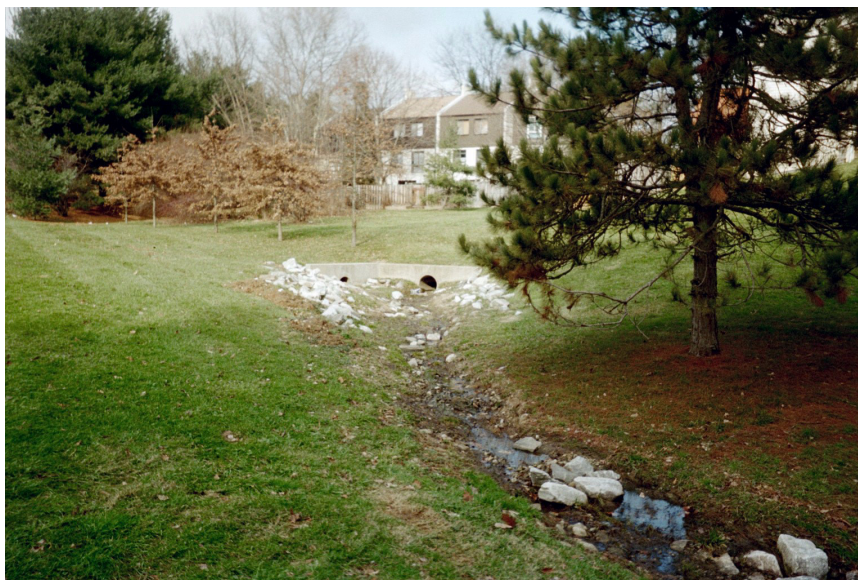
Figure 6: View of Outfall in Southern Boundary Area

At the back of Nightmist Court units 10321 to 10327 is an eroded swale caused by runoff with high velocity. The roof drains from these units and from unit 10331 are contributing to the runoff and velocity in the swale. The outfall area is in fair condition due to erosion and clogged storm drains.

An alternative recommendation is to create a site amenity bioretention area at the stormwater outfall (See **Figure 19**). See Section 6 for explanation of bioretention facilities.

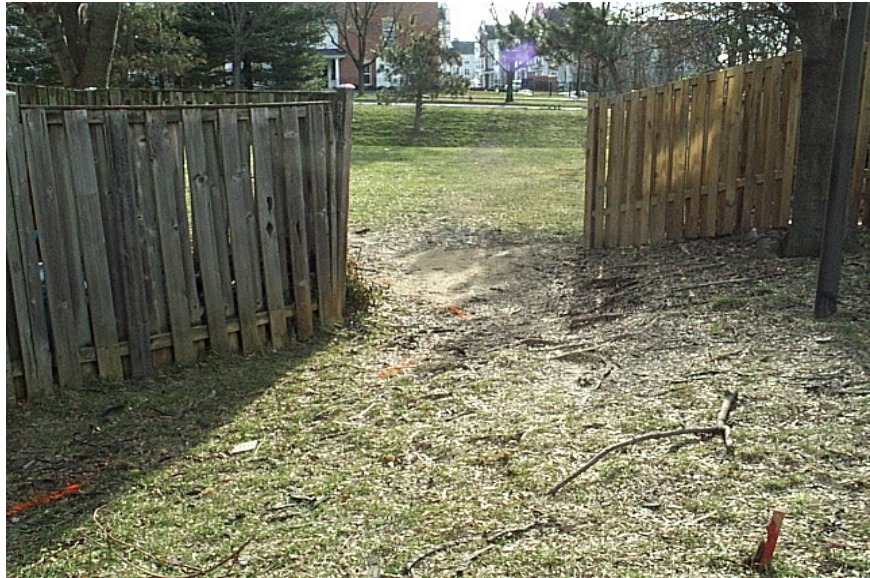
Behind Nightmist Court units 10311 and 10317 is a lawn area, which is in excellent condition. Between Nightmist Court units 10307 and 10311 the slope is in poor condition due to erosion caused by pedestrian traffic, dense shade, and runoff velocity (See **Figure 7**). The swale behind Nightmist units 10311 and 10317 is in fair condition due to erosion caused by runoff velocity and lack of vegetation to stabilize the slope.

Figure 7: Eroded Slope Behind Nightmist Units 10307 and 10311

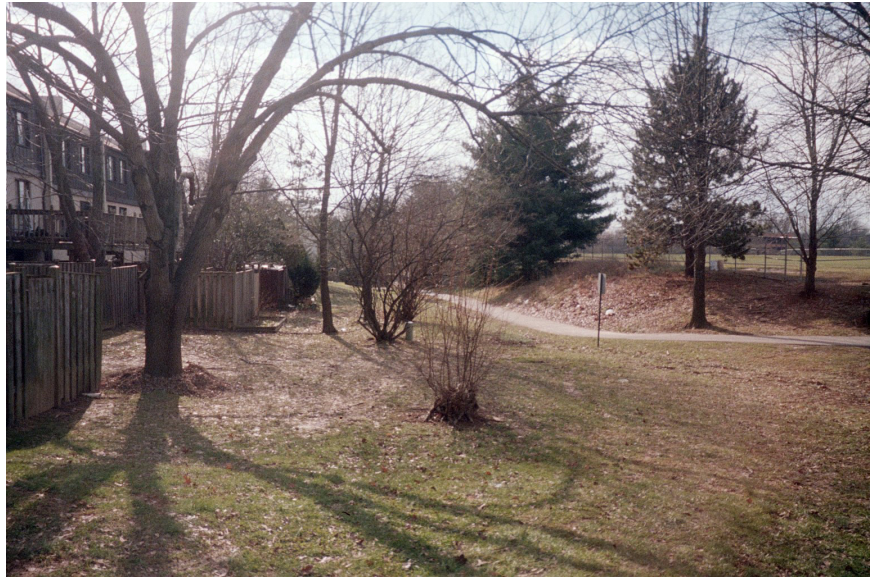
Between Daystar Court units 10315 and 10309 and the Nightmist Court units 10338 and 10330 the area forms a shallow depression where runoff ponds.

Figure 9: View of Western Boundary Area

The roof downspouts daylighting directly into the depression compounds the runoff ponding. There is a debris pile, which temporarily dams the runoff adjacent to Nightmist Court unit 10338. The swale ends adjacent to Nightmist units 10343 and 10339, where it forms a low depression.

Figure 20 shows the Western Boundary Area. Remove the debris pile and regrade the area between the low point at the northern end of the area and the swale along the trail to direct runoff and decrease velocity. Coordinate maintenance of low area with the adjacent property owner. Rehabilitate swale with Best Maintenance Practices (BMP's) along length of trail to decrease the velocity of runoff. Reshape swale as needed. Overseed with wet area grass mix to stabilize swale.

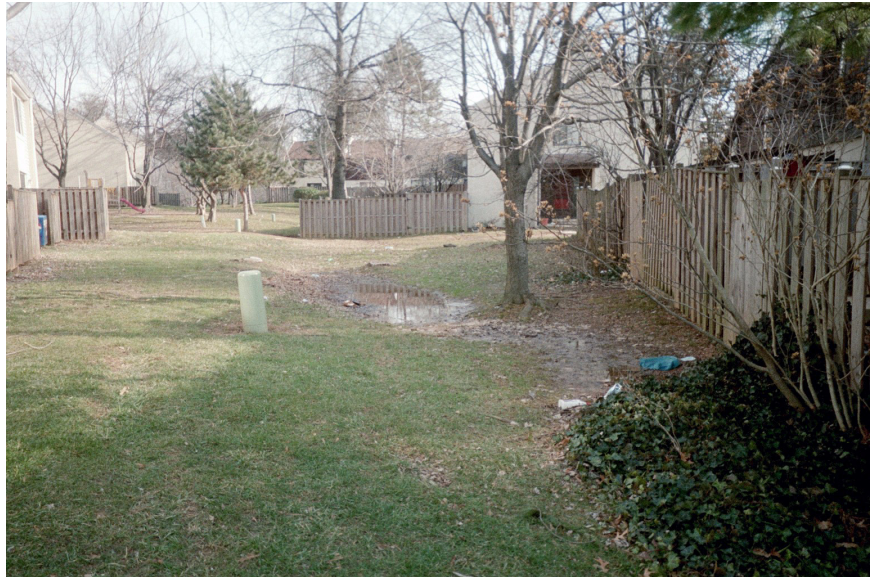
This area (See **Figure 10**) has severe erosion problems. Most of the problems are related to the worn and denuded paths created by pedestrians walking through Bryant Square and Roslyn Rise. The area directly behind and to both sides of Daystar Court units 10294 and 10304 is severely eroded. Compounding the erosion caused by foot traffic is the depressed ground, which acts as a swale channeling water toward the low spot behind Daystar unit 10316 (See **Figure 11**).

Figure 11: Erosion and Runoff Behind Daystar Unit 10316

A debris pile in the low spot acts like a dam blocking runoff. The runoff is channeled across the northwest corner of Daystar Court unit 10316. The roof downspouts daylighting just beyond the private backyard fences increases the runoff volume and velocity.

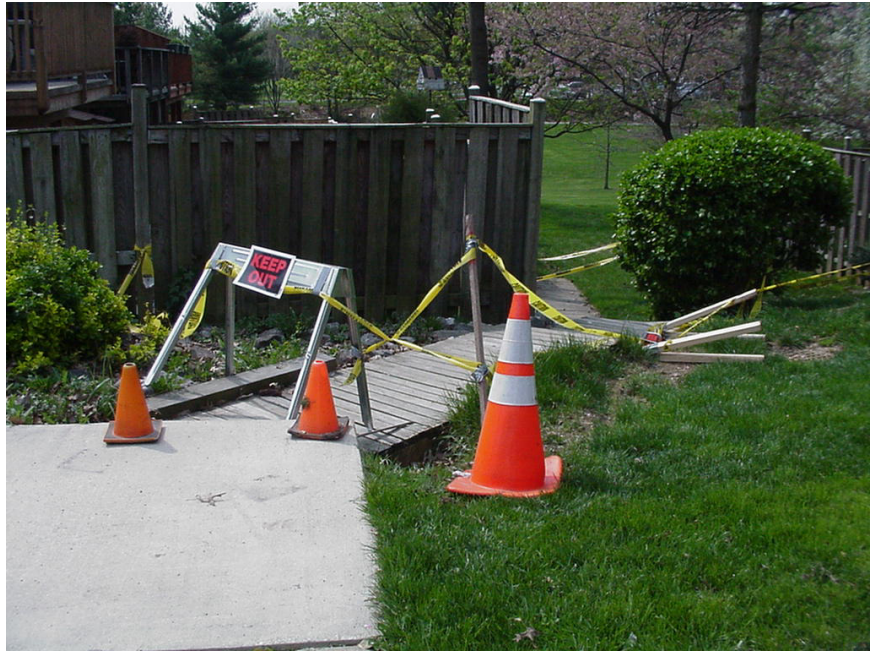
The wooden steps and slope between Nightmist Court units 10327 and 10331 is in poor condition (See **Figure 14**). The wooden steps are being undermined and the slopes are eroded due to excessive runoff.

Figure 14: Wooden Steps Undermined and Eroded Slope

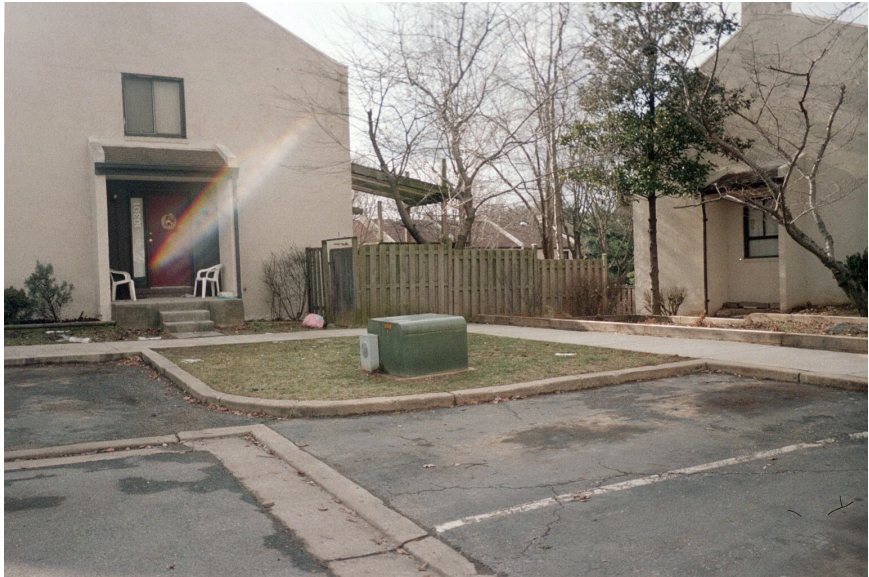
The asphalt parking areas in Daystar Court and Nightmist Court are in fair condition at the time of the site visit. (See **Figure 15**). The County-owned roadway was resurfaced in Spring 2003. The flush concrete curb and gutters are in good condition. The concrete wheel stops along the center-parking islands are damaged. The fire lane markings are worn and faded. The grass islands are only in fair condition due to surface erosion, debris, and empty homeowner trash cans blowing around the area. Some of the street signs are oriented incorrectly and the parking signs are inconsistent in design, size and placement.

Some of the planter areas around the parking area have had vegetation recently removed. The soil is disturbed and in some places bare soil is exposed.

Figure 15: Parking Area Nightmist Court

Figures 25 and 26 show the parking area of Daystar Court and Nightmist Court. Clean debris from storm drain inlets annually to prevent runoff from ponding. Howard County installed new paving on public roads in May 2003. Replace curb and gutter as required. Remove the concrete wheel stops and repaint fire lane markings. Re-orient and install street and parking signs with a consistent design and size. Regrade the planter areas around the parking areas and seed with a full-sun tolerant grass mix.

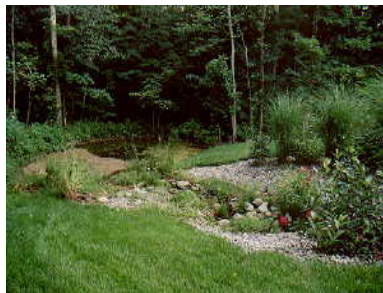
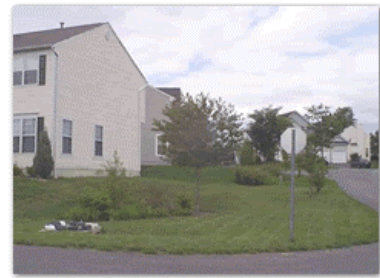
Figure 19: Examples of a Bioretention Amenity

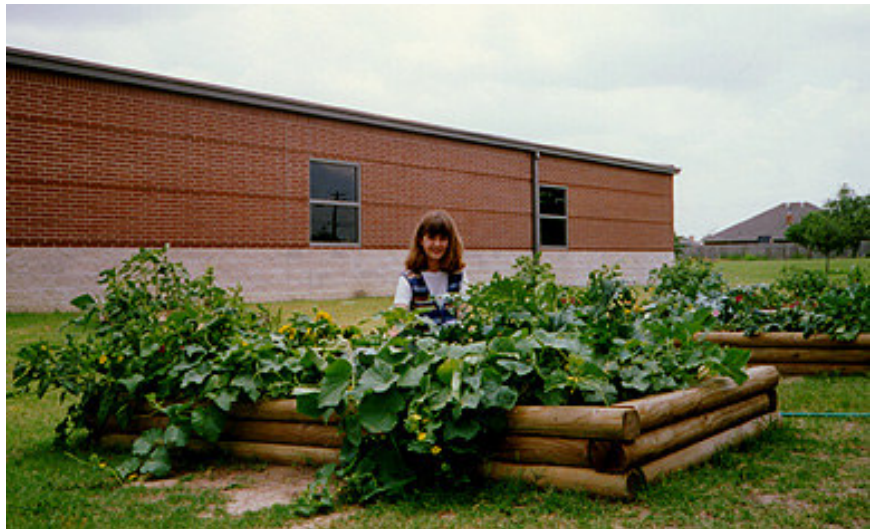
Figure 21: Example of a Community Garden

An alternative for this area is to create a community garden with plots (See **Figure 21**) for residents. Install additional plant material to direct pedestrian traffic along trail and deter walk-through traffic into Bryant Square.

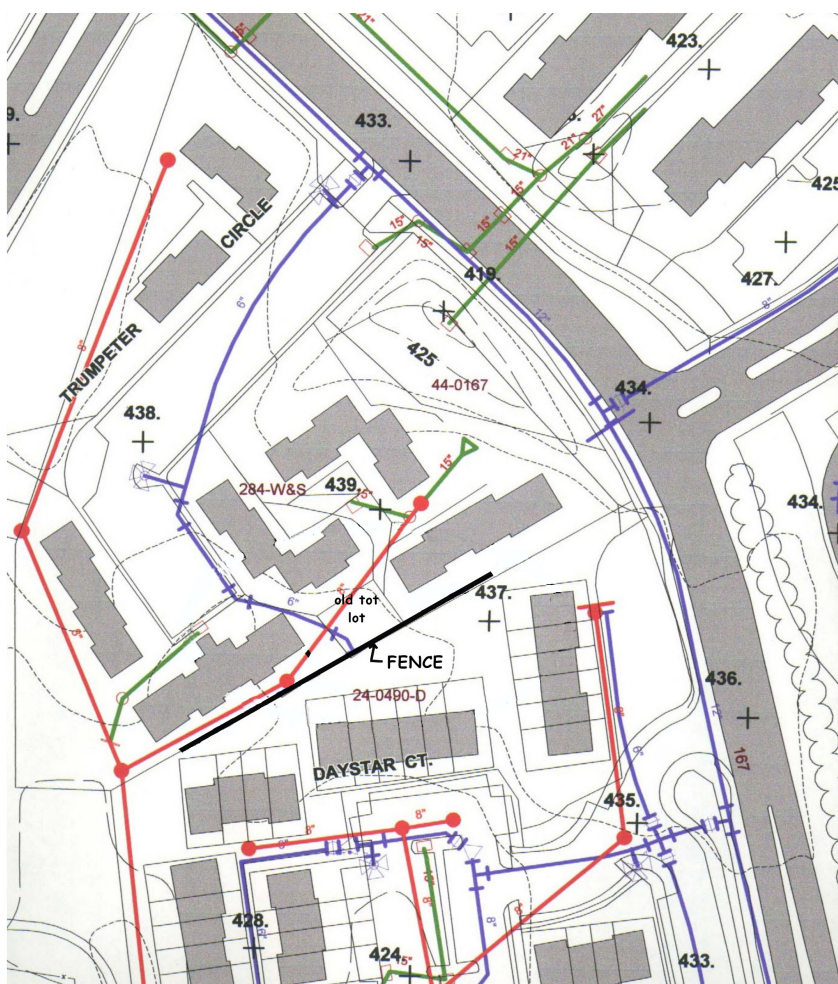
Figure 23: Fence Option Located Along Property Line

Figure 22 shows the Northern Boundary Area. To prevent continued erosion of soil and off-site pedestrian usage from using Roslyn Rise and Bryant Square as a short cut to other areas of Columbia, it is recommended that a physical barrier be erected between the two properties. A fence has been proposed along the property boundary and agreed to by both Roslyn Rise and Bryant Square according to representation of Bryant Square. One option is to install a 6-foot high fence along the property line that would extend toward Twin Rivers Road on the east and to the just beyond the townhouse on the west (See **Figure 23**).

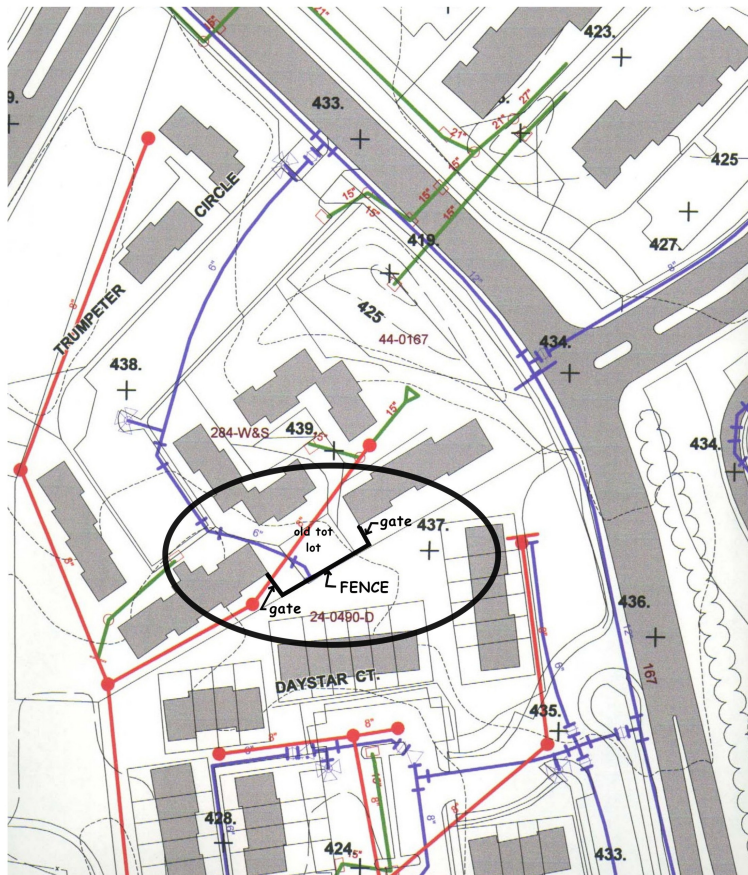
Figure 24: Fence Option Two-Enclosing Common Area Between Roslyn Rise Townhouses

There is no indication that pedestrians are traveling east to west along the shared property boundary to the extent of creating worn paths. By attaching the fence to the existing private property fences of Roslyn Rise, pedestrian walk-through traffic would be re-directed north of the property onto existing public sidewalks. Additional evergreen plantings at the east and west end of this area, will create the illusion that the fence prevents any through-access, and will help redirect this unwanted traffic.

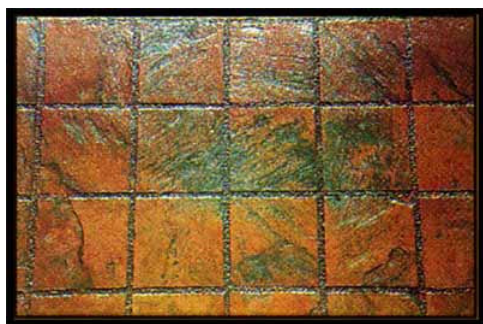
Figure 27: 4" X 4" Tile Pattern

An alternative is to remove the existing Hot Mix Asphalt (HMA) within each center parking island and replace with colored stamped concrete. A 4"x4" tile pattern (See **Figure 27**) in a medium gray color for the parking stalls and a single row of 4"x4" tile in a cream or light gray color (See **Figure 28**) for the stall striping is recommended. See **Figure 29** for the plan view and **Figure 30** for the section.

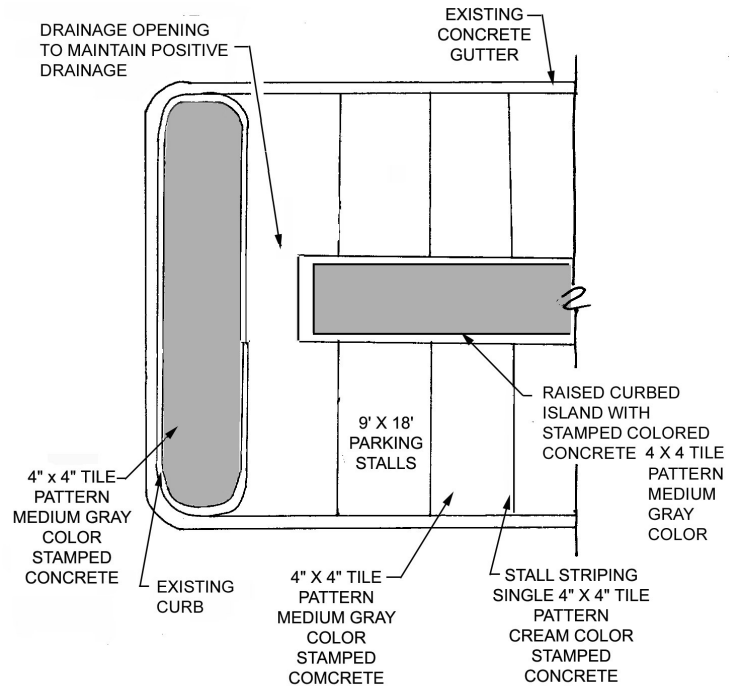
Figure 29: Alternative Parking Island Design for Daystar and Nightmist Court, Plan View

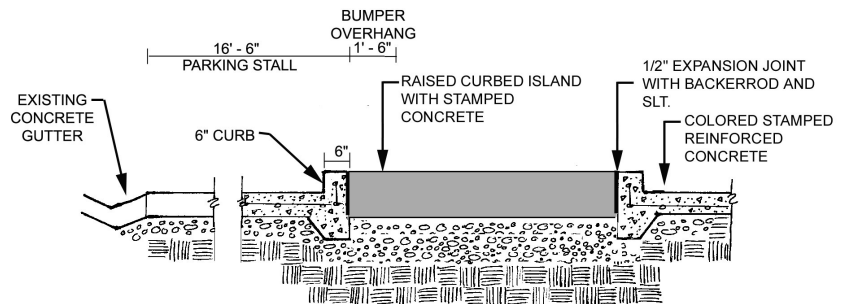
Figure 30: Alternative Parking Island Design for Daystar and Nightmist Court, Section

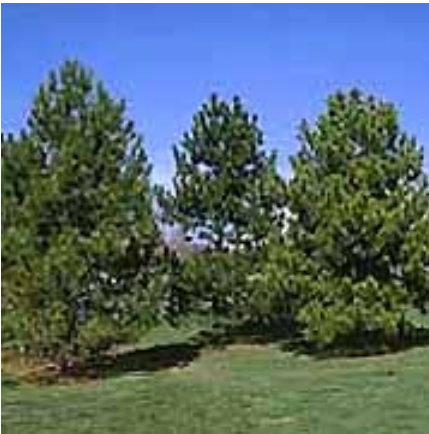
Figure 31: Austrian Pine

Austrian Pine (**See Figure 31**) is planted throughout the site. This pine does not age well, tends to naturally lose its lower limbs, and is susceptible to Diplodia, a twig blight, that can eventually kill the tree. The trees at Bryant Square exhibit both conditions and it is recommended that all Austrian Pine be removed and replaced with alternative evergreen trees.

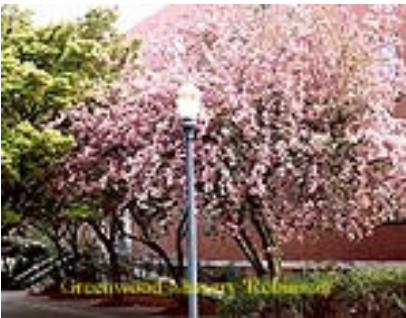
Figure 32: Flowering Crabapple

Flowering Crabapple (**Figure 32**) and Oriental Cherry (**Figure 33**) have a relatively short useful life in the landscape of approximately 30 years, unless meticulously maintained. Both species observed at Bryant Square are at the end of their useful life cycle, and it is recommended that they be removed and replaced with an alternate ornamental tree.

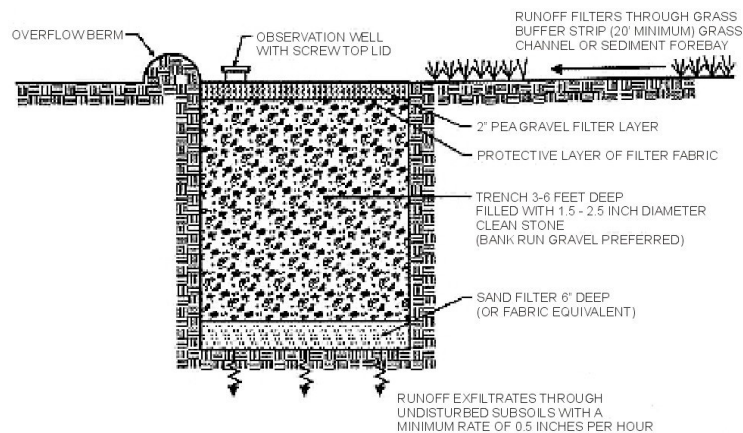
Figure 38: Infiltration Trench

An infiltration trench is a long trench with a perforated pipe within a gravel guard to distribute runoff throughout the length of the trench (See **Figure 38**). Infiltration trenches are often used to capture runoff from roof drains and downspouts. The primary benefits of an infiltration trench are that the trench allows runoff to infiltrate into the subsoil thereby decreasing the velocity and volume of runoff flowing over the ground, which reduces erosion.

A SCHEMATIC OF AN INFILTRATION TRENCH (Source: MDE, 2000)

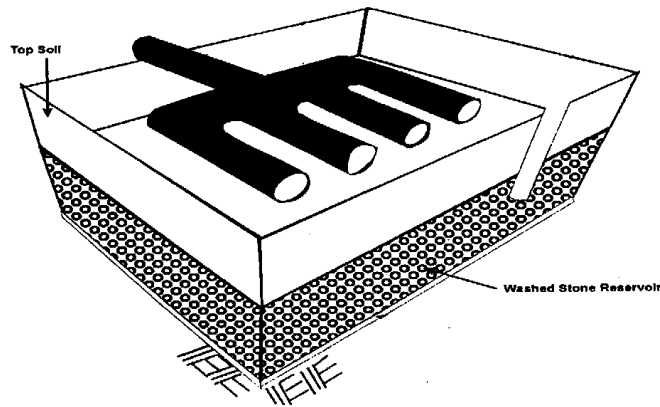
An infiltration gallery (See **Figure 39**) is designed to deliver captured runoff to the subsoil through subsurface reservoirs composed of gravel. These structures are below grade (do not see them) and provide an innovative stormwater treatment in areas where space is limited.

Figure 2 - Typical Infiltration Gallery – Source: Metropolitan Washington Council of Governments, 1987

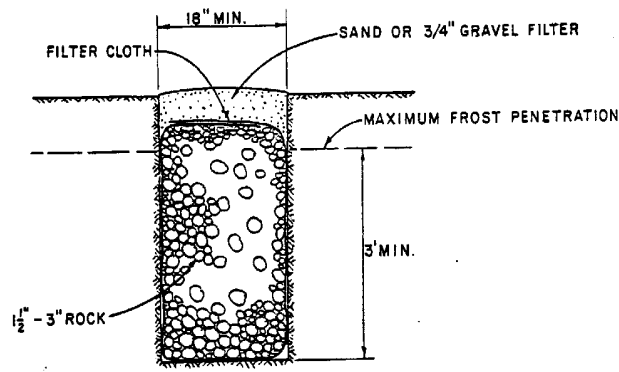
Dry wells are stone or gravel pits (See **Figure 40**) used to infiltrate runoff from impervious surfaces (parking lots for example). Typically several shallow dry wells are installed, as they are more effective than a single large deep well. Often french drains are used as a dry well.

Figure 3 – Typical Dry Well – Source: TRPA Handbook of Best Management Practices, 1988

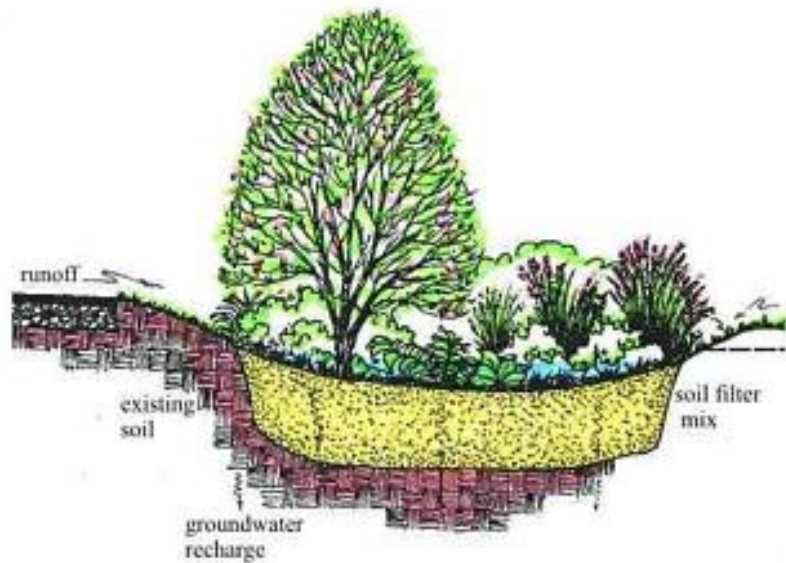
Figure 41: Example of a Bioretention System

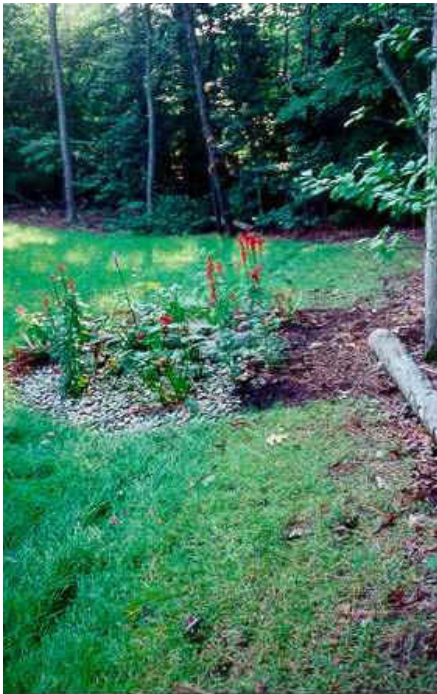
Figure 42: Example of a Rain Garden

One such amenity is often called a rain garden (see **Figure 42**). Rain gardens are shallow depressions designed to collect rain, typically from impervious surfaces such as roofs and parking and allow plants, bacteria, and soils clean the water as it seeps its way into the ground. The site for the rain garden should be placed strategically to intercept water runoff. The first flush of runoff is ponded in the depression of the rain garden and over a short period of time the water infiltrates into the subsoil.

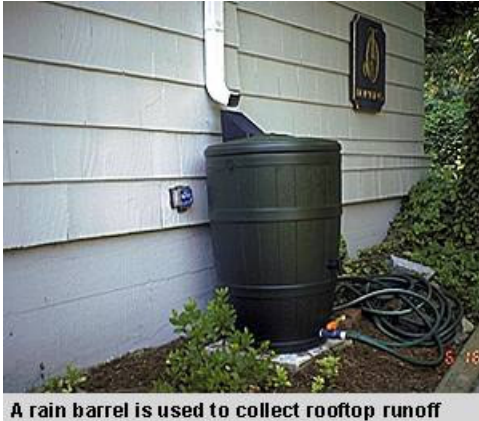
Figure 43: Example of a Rain Barrel

Storage includes practices that hold rooftop runoff for use by the individual homeowner or slowly release it for capture in an infiltration or diversion structure. Examples of storage systems include cisterns and rain barrels (see **Figure 43**) are the simplest in design of all the on-lot treatment systems. They are available commercially and can be applied in a wide variety of site conditions.

A rain barrel is used to collect rooftop runoff
